Publication No. 1C0948
August 1996

FILM ARTIFACT DIAGNOSTICS GUIDE for *Kodak X-Omat* Automatic Film Processors

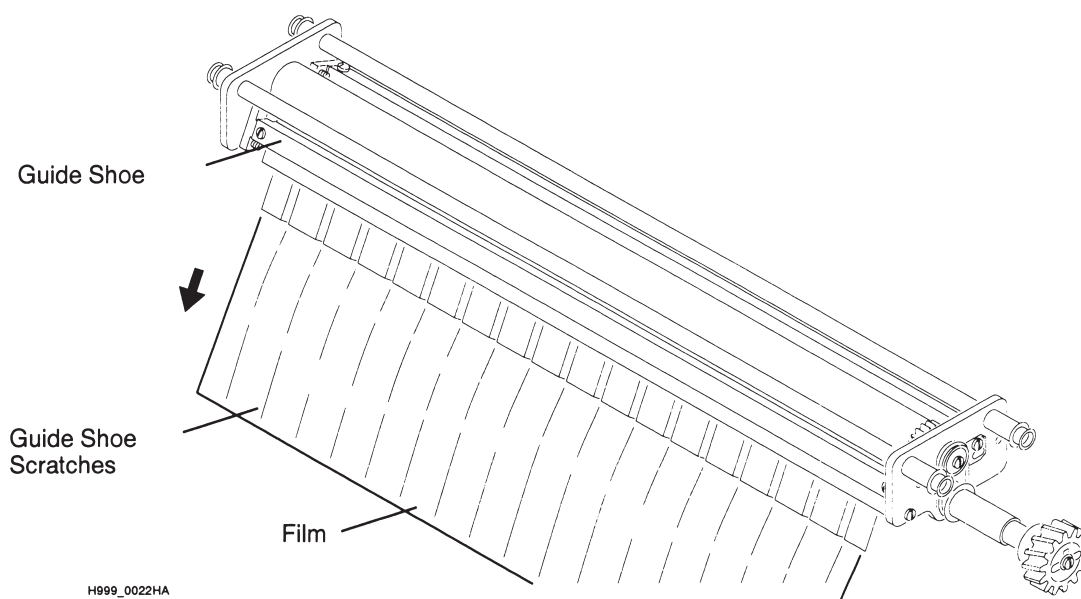
Figure 5 Identifying Scratches Caused by Guide Shoes in the Crossover Assemblies

If the Guide Shoes in the Crossover Assemblies are not correctly installed, the Guide Shoes can potentially scratch or mark the top surface of the film. Guide Shoe Marks can appear as either plus or minus density scratches. Guide Shoe Marks are typically easy to identify because they appear at regular intervals.

- Guide Shoe Marks caused by ribbed Guide Shoes appear at 25.4 mm (1 inch) or a multiple of 25.4 mm (1-inch) intervals.
- Marks caused by textured Guide Shoes appear at 0.06 mm (1/16 inch) or a multiple of 0.06 mm (1/16-inch) intervals.

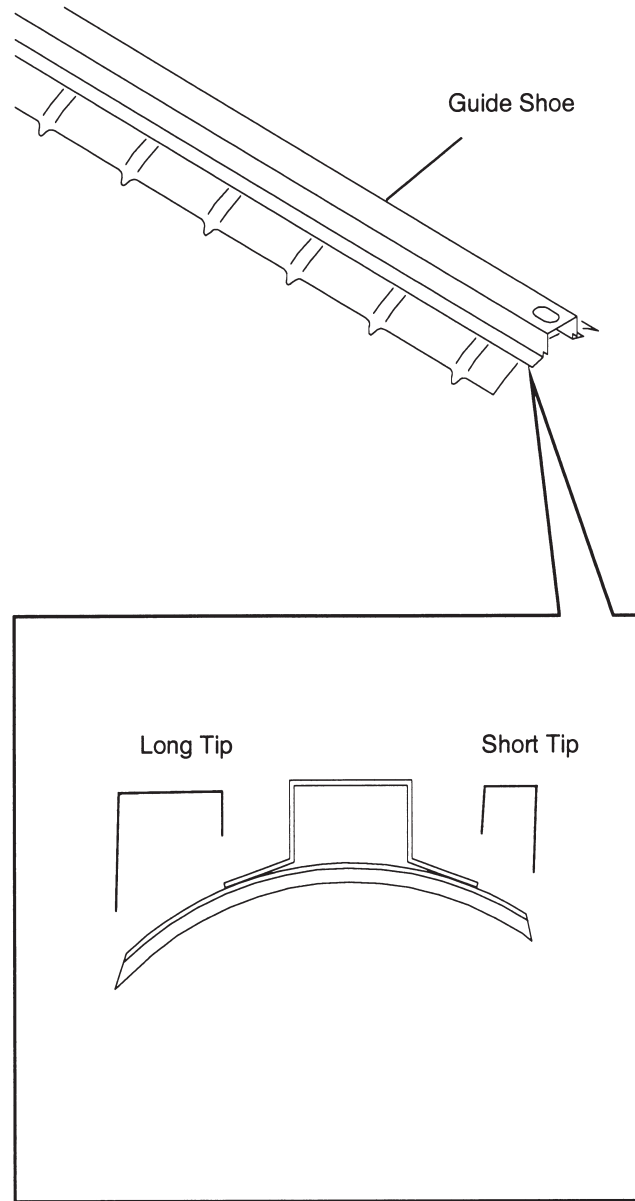
Figure 7 Identifying Nicks Caused by Guide Shoes

As a result of their contact with the Guide Shoes, both the leading and trailing edges of the film may acquire artifacts. Most often the artifacts appear as nicks measuring up to, but not exceeding, 0.3 mm (1/4 inch). The position of the nicks on the film will directly correspond to the location of the Tips on the Guide Shoes.

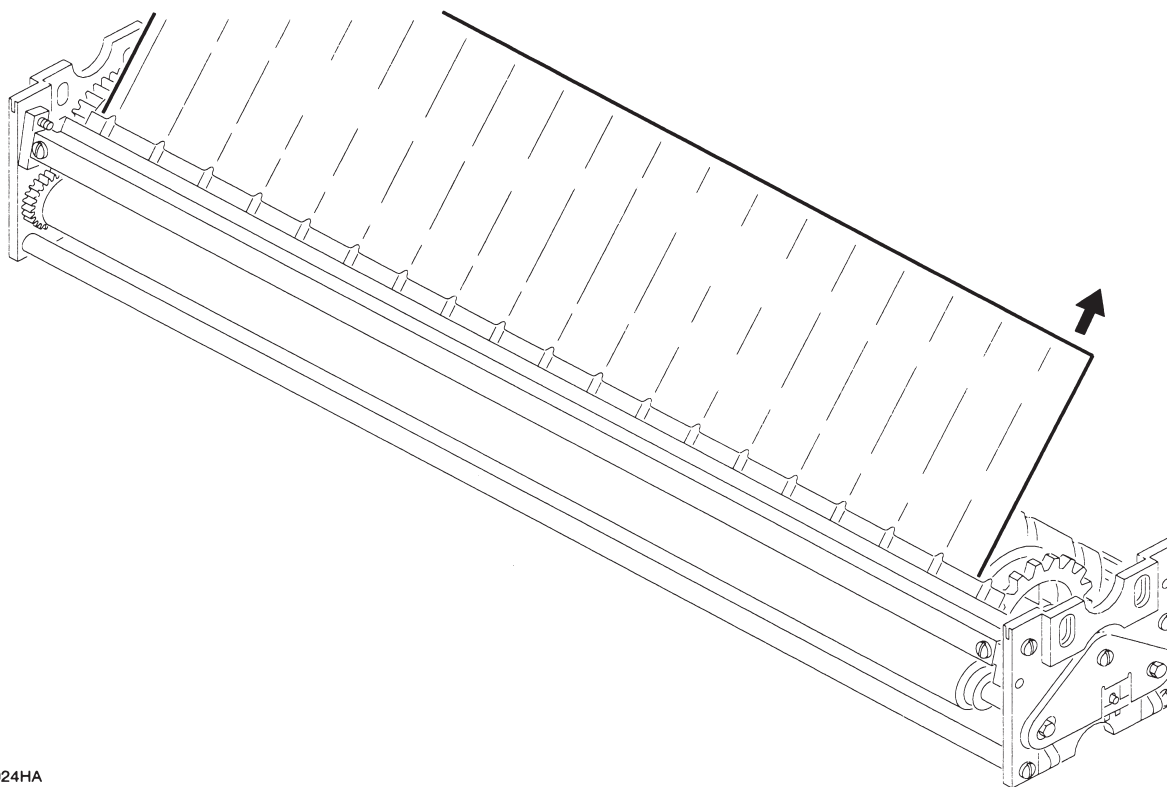
Figure 10 Identifying Scratches Caused by Guide Shoes in the Turnaround Assemblies

If the Guide Shoes are not correctly installed in the Turnaround Assemblies, the Guide Shoes can potentially scratch or mark the bottom surface of the film. Worn Roller Bearings can also contribute to unwanted scratches and marks on the film. When the components of the Rollers wear, they can sometimes drive the film off the normal path and cause the film to contact the Guide Shoes, thus causing scratches on the film.

- Guide Shoe Marks caused by ribbed Guide Shoes appear at 25.4 mm (1 inch) or a multiple of 25.4 mm (1-inch) intervals.
- Marks caused by textured Guide Shoes appear at 0.06 mm (1/16 inch) or a multiple of 0.06 mm (1/16-inch) intervals.

Scratches or marks caused by Guide Shoes possess one other identifying characteristic. The scratches or marks are parallel to the direction of the film travel.

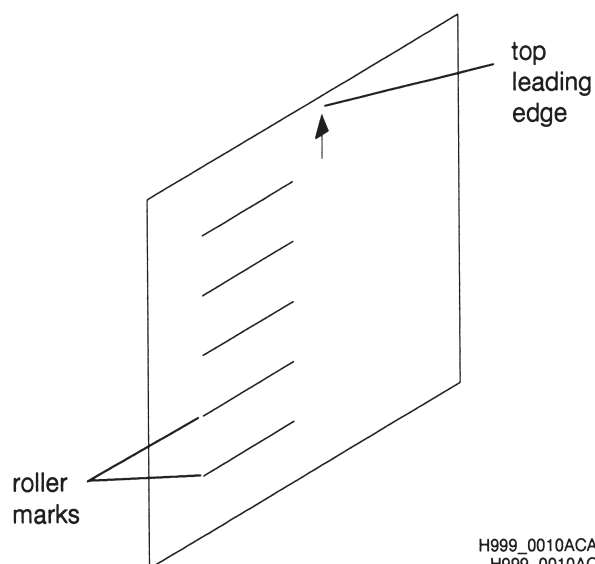
Figure 12 Identifying Artifacts Caused by Inner and Outer Path Rollers

The Rollers in the outside path of the Developer, Fixer, or Wash Rack contact the bottom surface of the film. Any scratches or marks caused by the Outer Path Rollers occur on the bottom surface of the film.

The Rollers in the inside path of the Developer, Fixer, or Wash Rack contact the top surface of the film. Any scratches or marks caused by the Inner Path Rollers occur on the top surface of the film.

Diameter of the Roller	Circumference of the Roller $\pi \times \text{Diameter}$	Space Between Artifacts
25.4 mm (1 inch)	79.8 mm (3.14 inches)	79.8 mm (3.14 inches)
50.0 mm (2 inches)	159.5 mm (6.28 inches)	159.5 mm (6.28 inches)

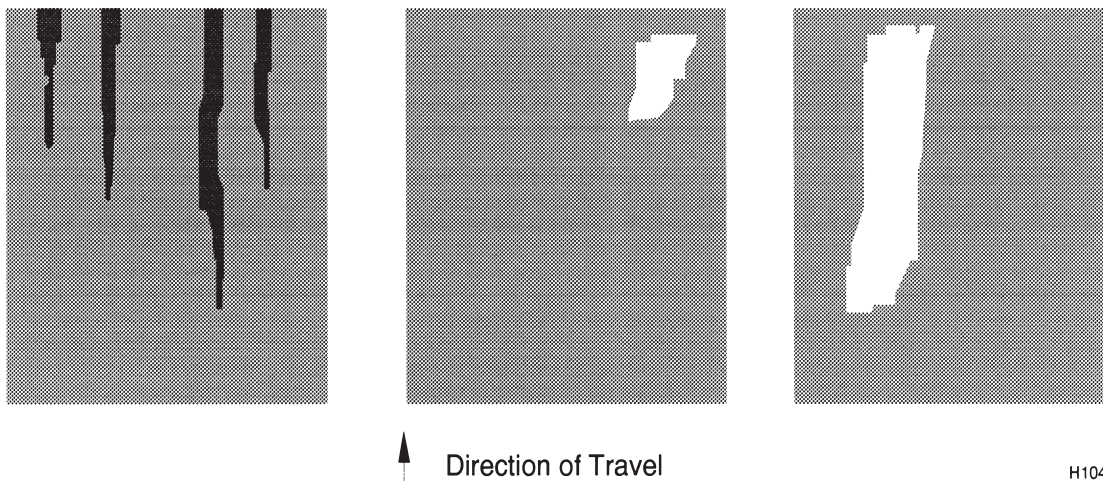
Delay Streaks:

Delay Streaks are visible in transmitted and reflected light.

- chemical buildup on the Developer/Fixer Crossover Rollers or the Squeegee Rollers of the Developer Rack
- low level of developer solution in the Developer Tank
- improper ventilation and darkroom air pressure
- improper leveling of the processor
- Evaporation Covers not installed

- Clean any dirty Rollers. If necessary, replace damaged Rollers.
- If the processor has been in Standby Mode for over 30 minutes, feed a sheet of cleanup film into the processor before you process the patient's film.

- Check that the Springs in the Racks are adjusted to the proper tension.
 - The Rewet Roller in the Rack must remain in contact with the Roller that is above the solution level. The Rewet Roller transfers solution to the Roller above the solution level in order to prevent chemical buildup.
- Check that the Developer Tank is full of solution.
- Check that the processor is vented correctly using the manufacturer's specifications.
- Check that the processor is level.
- Check that the Evaporation Covers are installed.

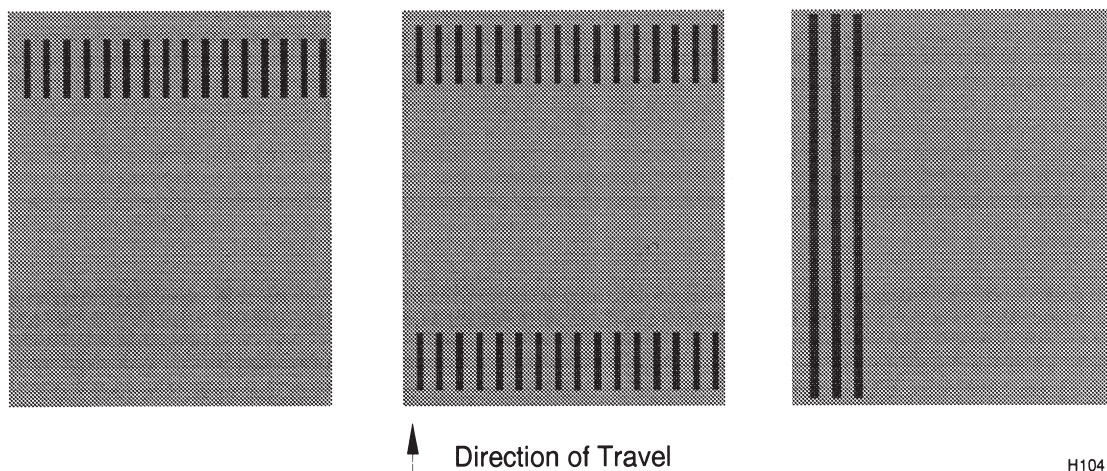
Entrance Roller Marks:

Entrance Marks are most visible in transmitted light, but in severe cases are also visible in reflected light.

- Check that the Entrance Roller Assembly is positioned correctly in the processor.
- Check the Entrance Roller Assembly for:
 - squareness
 - warped or defective Rollers
 - worn Bearings
- Clean the Entrance Rollers with a damp cloth and dry them thoroughly before you process any patient films.
- Check that the processor is vented correctly using the manufacturer's specifications.

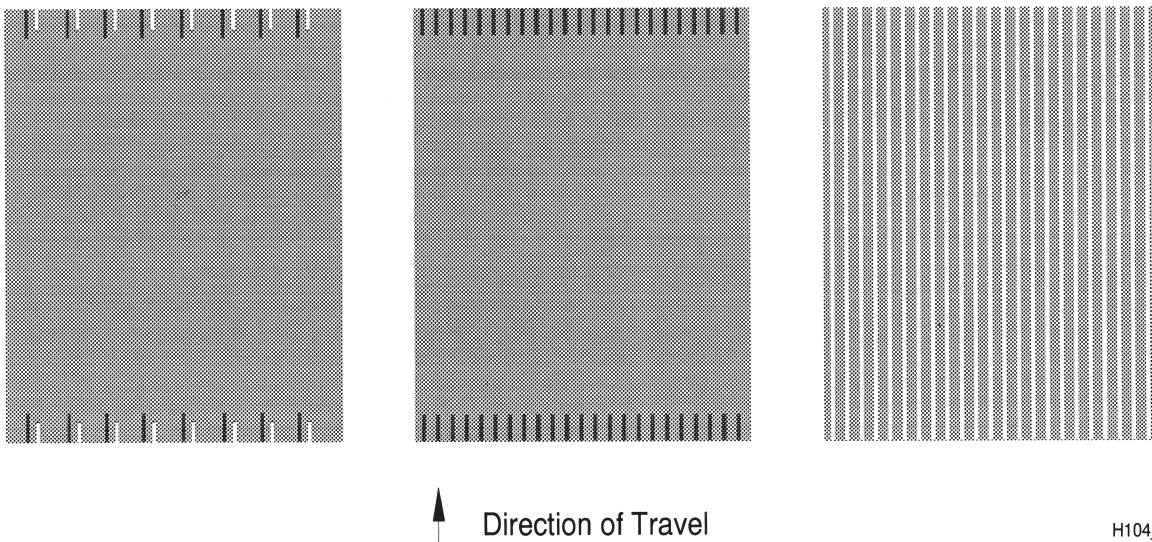
Guide Shoe Marks (May be Plus or Minus Density):

Guide Shoe Marks are visible in either transmitted or reflected light.

- Check that all Rollers are straight and rotating correctly.
- Check all the Racks for squareness.
- Inspect all Guide Shoes, and replace any bent Guide Shoes.
- Check the Roller Bearings for wear. If necessary, install new Bearings.
- Inspect all Rollers for dirt or a buildup of dried chemicals. Clean the Rollers according to the manufacturer's recommendations. Do not use abrasive materials to clean the Rollers or Guide Shoes.

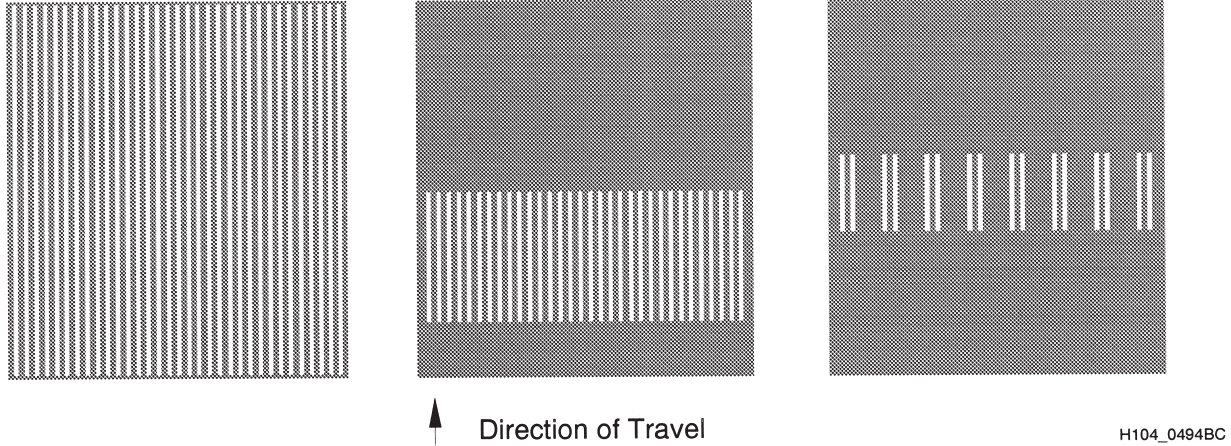
Minus Density Lines:

Appearance: Minus Density Lines appear as light streaks and are normally visible only in transmitted light.

- dirty Exit Guide Shoe in the Fixer/Wash Crossover
- bent Guide Shoes in either the Wash or Dryer Racks
- worn Bearings in the Fixer or Wash Turnaround Assemblies

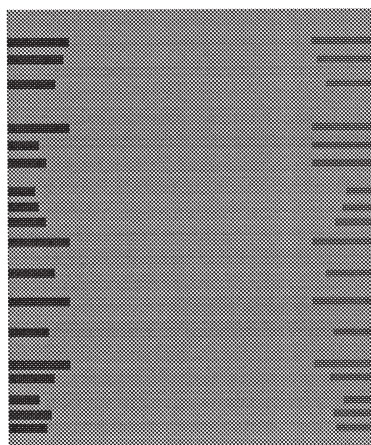
Chatter:

Chatter Lines are most visible in transmitted light, but in severe cases are also visible in reflected light.

- Adjust the drive system on the Developer Rack or Developer/Fixer Crossover Assembly according to the manufacturer's recommendations.
- Check for worn or damaged Sprockets that could prevent correct meshing with the Chain.
- Check for the correct tension of the Rack Chain.
- Check whether the Chain on the Drive Motor is worn or corroded. If necessary, install a new Chain.
- Install a new Ladder Chain.
- Do the Periodic Maintenance procedures as outlined in the Service Manual.

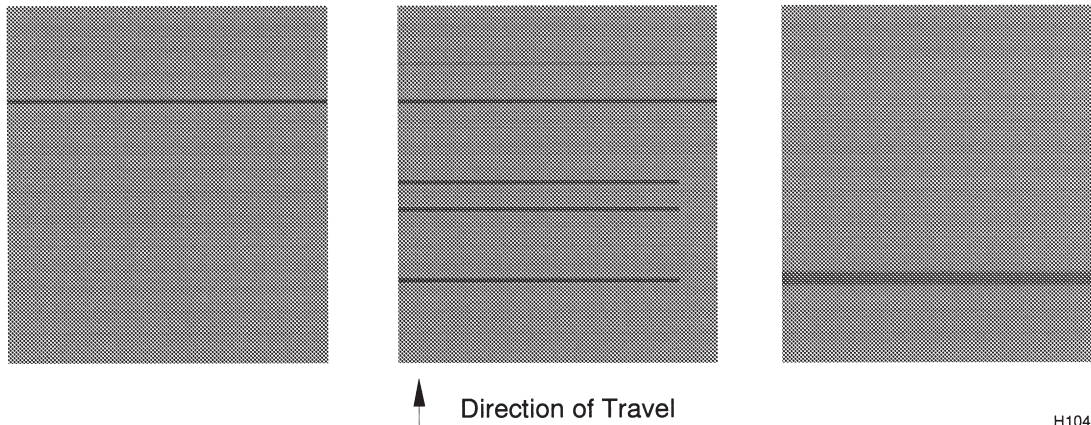
Stub Lines:

Film Hesitation Marks are usually visible in transmitted light.

- Check that the Developer Rack and Developer/Fixer Crossover are assembled correctly.
- Mix new processing chemicals.
- Check the replenishment rates of the developer and fixer solutions.
- Check for kinks or air bubbles in the Replenishment Hoses.
- Inspect all Rollers for dirt and a buildup of dried chemicals. Clean the Rollers according to manufacturer's recommendations. Do not use abrasive materials to clean Rollers or Guide Shoes.

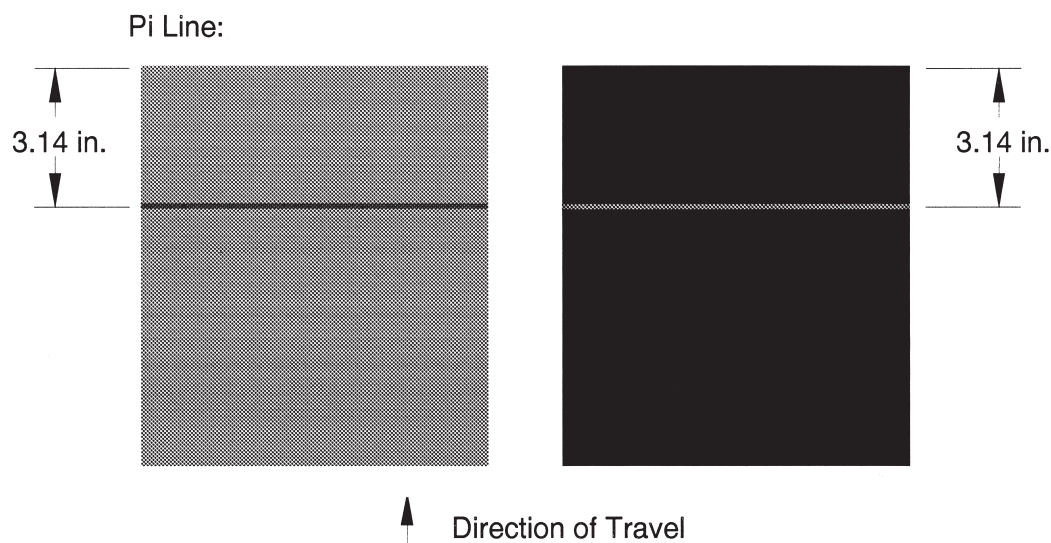
Pi Lines can be first seen in reflected light. As the severity of the Pi Line artifact increases, you will be able to see the lines in transmitted light. In the most severe cases, you will be able to see the Pi Line repeat every 79.8 mm (3.14 inches) for the entire length of the film with each occurrence being less dense than the previous.

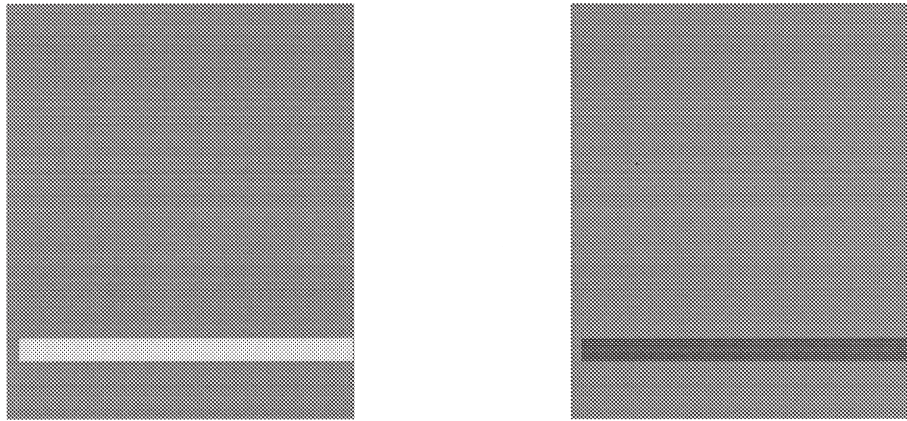
Slap Lines:

Slap Lines are normally visible only in transmitted light.

- Check replenishment levels.
- Adjust the replenishment rates.
- Mix new processing solutions.
- Use the Rollers recommended by the processor manufacturer.
- Check that the Guide Shoes in the Developer/Fixer Crossover are correctly positioned and are not damaged.

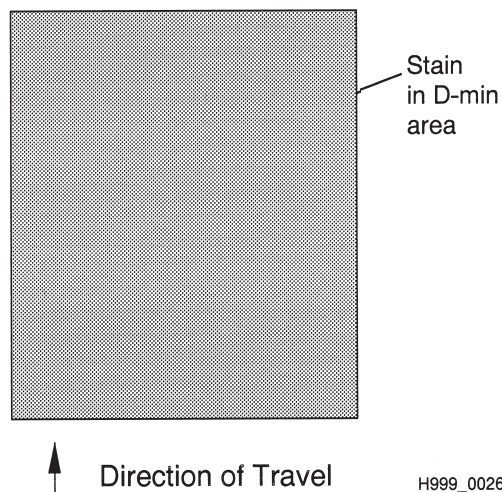
Dye Stain:

Dye Stain Marks are visible when you view the film.

- incomplete removal of the sensitizing dye resulting from
 - inactive processing solutions
 - fixer replenishment rate set too low
 - fixer or water temperatures set too low
 - increased transport speed through the fixer solution

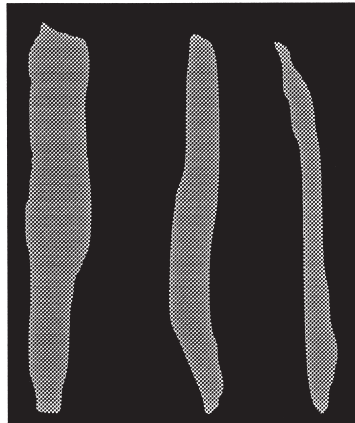
Surface Drying Streaks:

- worn Squeegee or Dryer Roller Bearings
- insufficient squeegee action
- too much airflow
- poor drive in Dryer
- intermittent Interlock Switch
- processing film in incorrect chemical solution
e.g., use of RP film with RA chemicals
- exhausted chemistry
- level of wash water that is too low
- Dryer Belt that is too loose
- incorrect type of film or chemicals used for the processor model
